Anderson-Cottonwood Irrigation District **Operations Report** June 12, 2025 — July 3, 2025

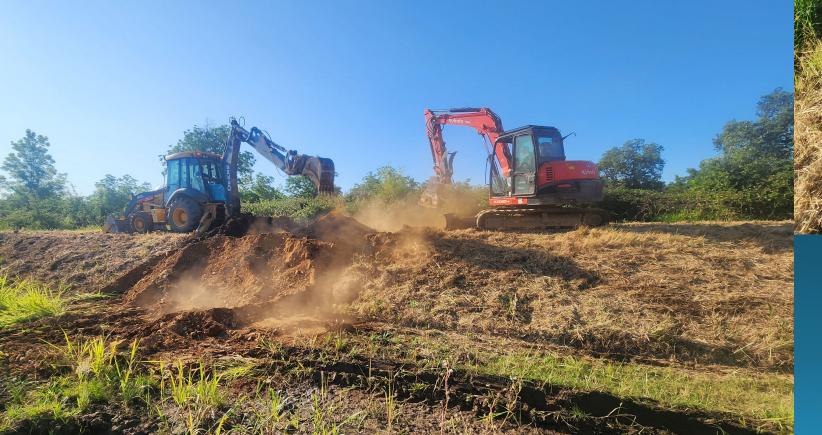
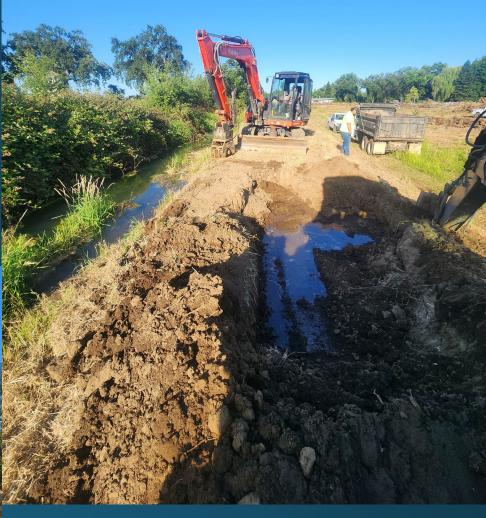
Lateral 21.3

- Core bank to repair leaking rodent holes
- No interuption in service
- More water back in the ditch
